## Building Resilience to Sea-level Rise on the Albemarle-Pamlico Peninsula

Dr. Christine Pickens, Coastal Restoration and Adaptation Specialist The Nature Conservancy of North Carolina April 29, 2014

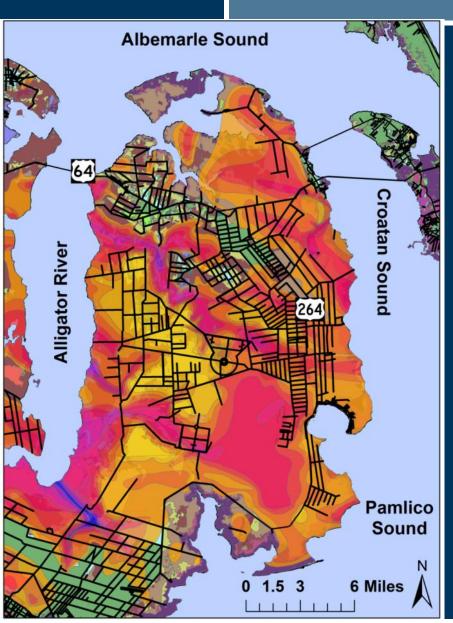
## Ditching and Drainage

### **Ditches**

- Dries out peat soil
- Subsidence
- Salt water moves in toward inner swamps (salt water intrusion)

### Roads

- Reduce water
   movement across the surface of the ground
- Can create ponding effect

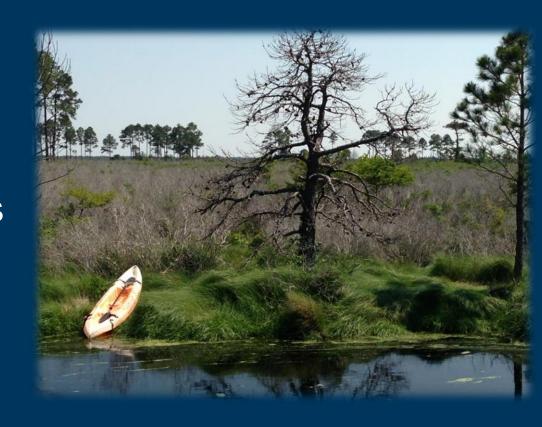
## Pains Bay Fire (2011)

#### USDA Forest Service FORWARN Model

- 45,294 acres
- Lasted 120 days
- Cost \$14,000,000
- Millions of tons of carbon lost to the atmosphere (Mickler)

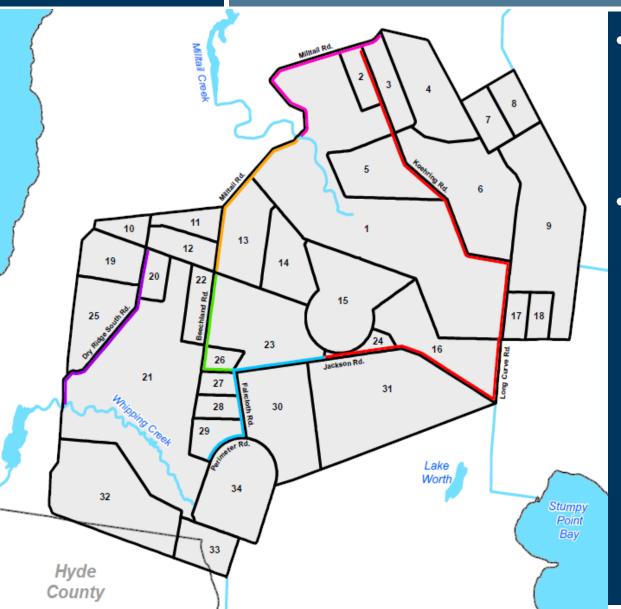
## Important Water Reaches

- 6 Major Reaches that allow water to flow through the area
- Important for fire management
